SPERRY MARINE UK
Service Bulletin No. 49

Product: **BridgeMaster E Series Radars**

Subject: **Advisory Notice: S Band Turning Units**

NORTHROP GRUMMAN SPERRY MARINE
ADVISORY NOTICE
January 2004

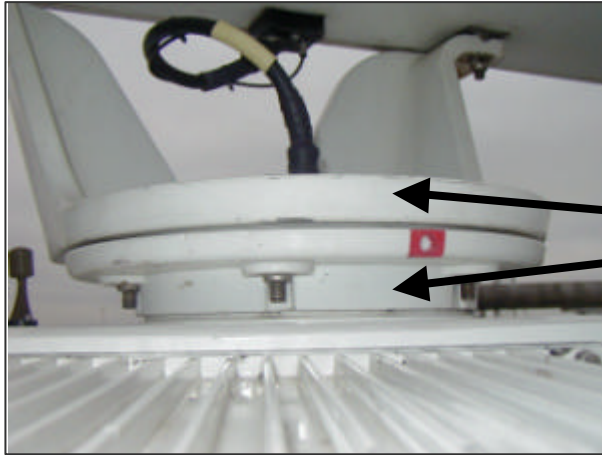
1. Visually inspect the entire torque tube & turntable at areas indicated. Check for anything abnormal such as signs of wear, damage, corrosion or cracks.

EXAMINE THESE
AREAS AROUND
THE WHOLE
CIRCUMFERENCE

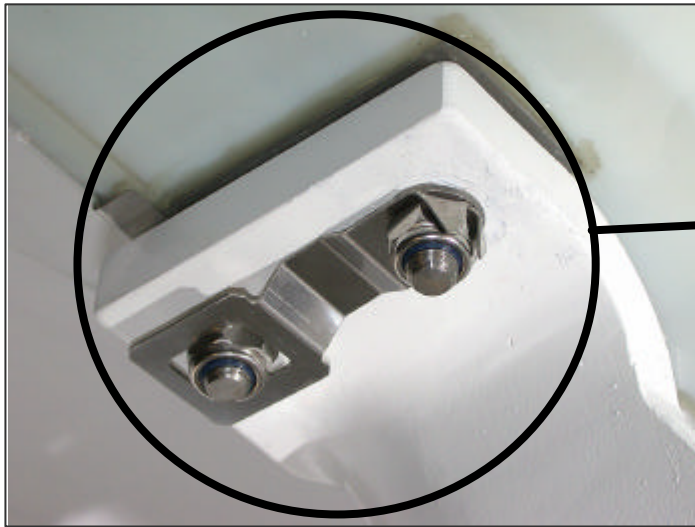
2. Visually inspect the antenna and support casting at the areas indicated. Look for anything abnormal such as signs of wear, damage, corrosion or cracks.

EXAMINE THIS
AREA

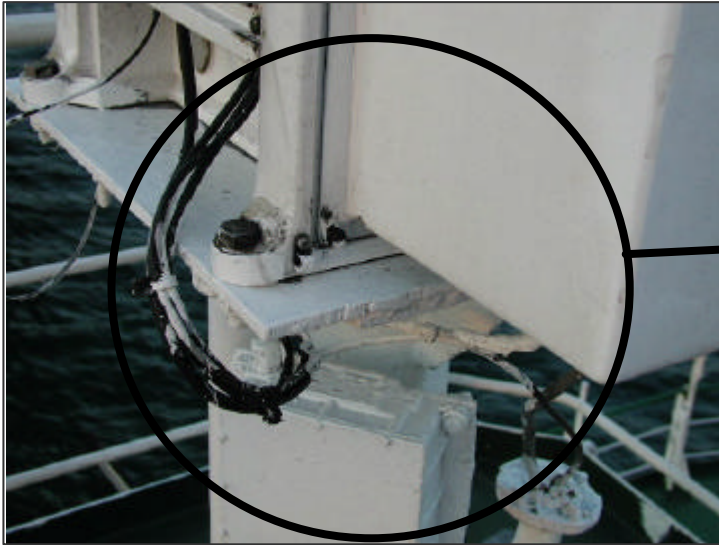
3. Visually inspect the condition of the securing arrangement of the turning unit to the support structure. Check for signs of wear, damage, corrosion or cracks.

EXAMINE THESE
AREAS

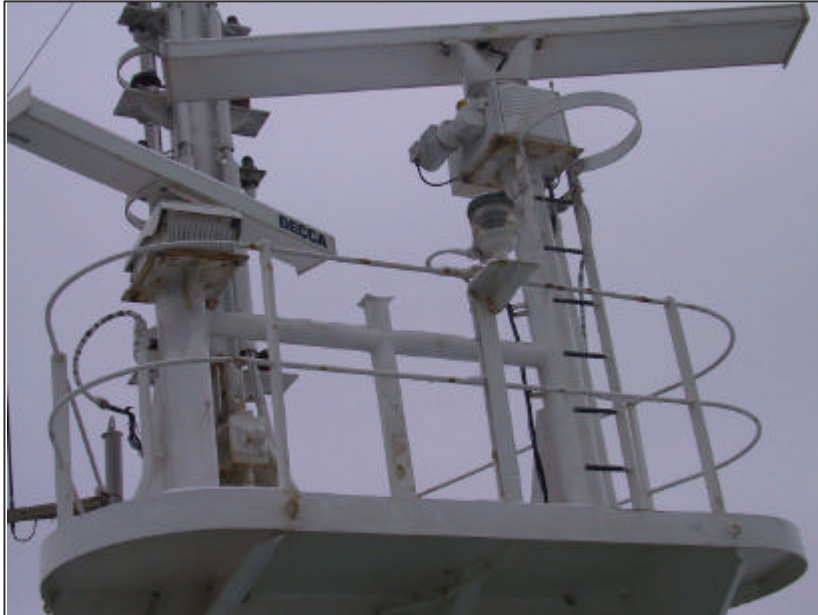
4. Visually inspect the condition of the support structure for corrosion, rigidity or damage to integrity. Check that the support structure is mechanically suitable for the purpose of holding the radar head in position without excessive vibration or shock.
