SPERRY MARINE UK
Service Bulletin No. 57

Product: Decca BridgeMaster E Series Radars

Subject: S Band Turning Units Intermittant Azi Error

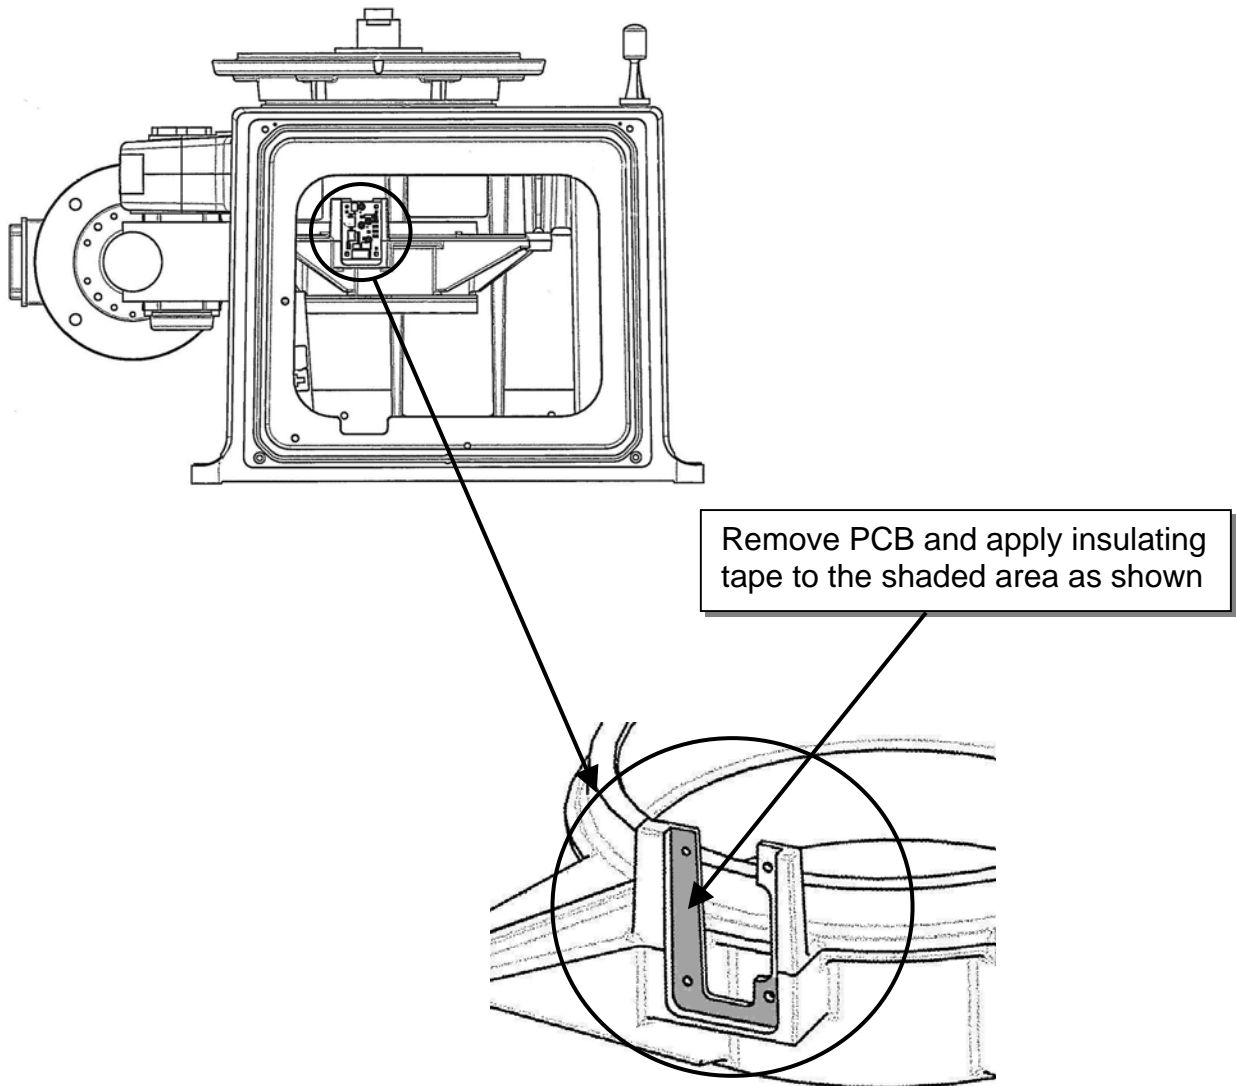
It has become apparent that with type 65801805-3 Bearing and Heading Marker PCB it is possible that the +12 volt can get shorted to earth when fitted in a BME S Band Turning Unit.

Symptoms vary from intermittent to permanent Azi Error alarms and Scanner Control Unit contactor dropping out.

It is advised that when this is experienced, suitable insulating tape is applied to the metal housing underneath the PCB. Do not apply the tape to the PCB as when the PCB is replaced at a later date, similar problems might re-occur.
