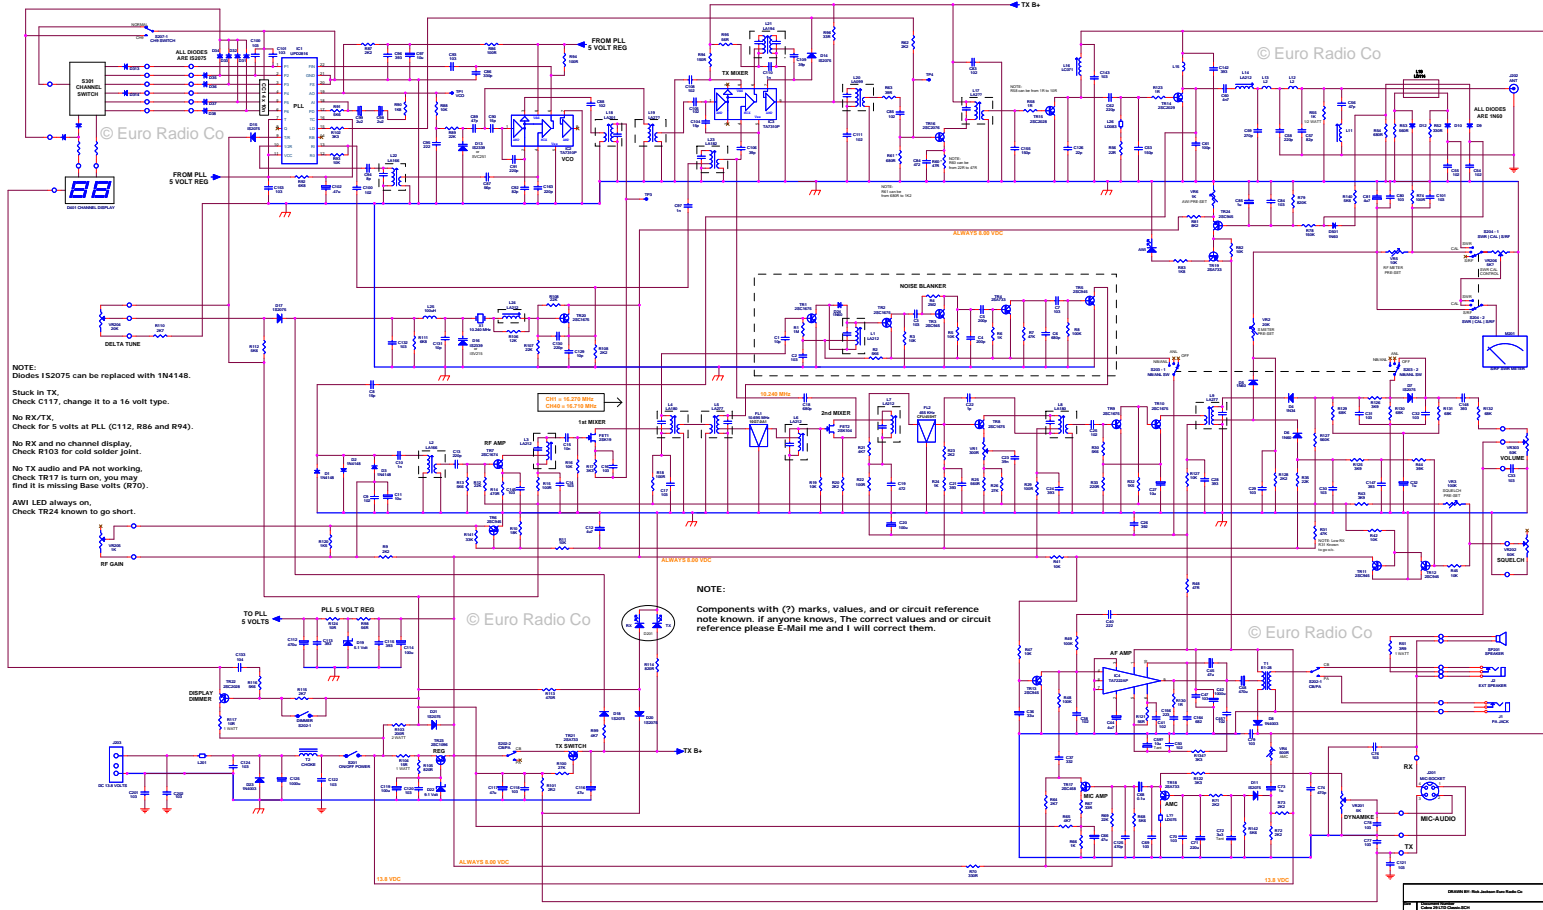
NOTE:
 Diodes 1S2075 can be replaced with 1N4148.
 Stuck in TX,
 Check C117, change it to a 16 volt type.
 No RX/TX,
 Check for 5 volts at PLL (C112, R86 and R94).
 No RX and no channel display,
 Check R103 for cold solder joint.
 No TX audio and PA not working,
 Check TR17 is turn on, you may
 find it is missing Base volts (R70).
 AWI LED always on,
 Check TR24 known to go short.

CH1 = 10.275 MHz
 CH2 = 10.770 MHz

NOTE:
 Components with (?) marks, values, and or circuit reference
 note known. If anyone knows, The correct values and or circuit
 reference please E-Mail me and I will correct them.
