MODIFICATION INSTRUCTION SHEET No DX/14-1

EQUIPMENT AFFECTED: BridgeMaster E Flat Panel Monitors, 65823A and 65823B, 65817G and 65819A.

OBJECT AND METHOD: On a few occasions horizontal perturbations and mild interference (speckle) can be observed on the FPD within the blue radar circle and on the grey drop down menus. The following modification to fit the filter box or cable can significantly reduce this interference.

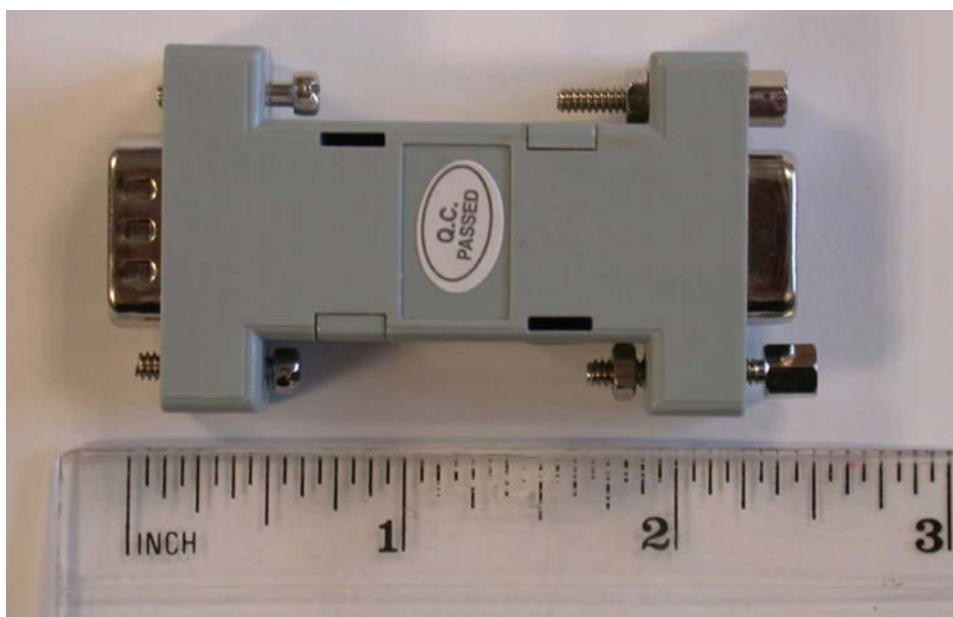
Item	Description	Code No	Qty
1	Filter box (see picture) (An alternative cable 65800552 may be supplied instead)	MA00015156	01

- 1 Switch off the radar system and switch off the FPD (a long press at the On/Off switch on the FPD).
2. Disconnect the connector at SKS at the rear of the Processor Electronics Unit and fit the filter box or cable **IN LINE** with the existing video cable between SKS and the FPD.
